Stillwater Mine | Ore Tracking Case Study

Sibanye-Stillwater

Transition from HDPE beading of muck to TopVu RFID muck tracking.

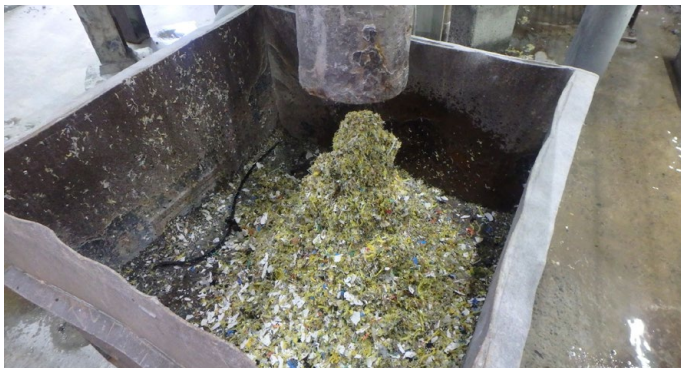
Mill trash screen separator overflow where we check for beads.

At the time, we were using HDPE beads which we would deploy into the rock piles. Mill personnel would notify us whenever they saw these plastic beads coming through the trash screen separator. This process had the ability to act as an indicator of mis-ship, but only after the waste had made it through the mill.

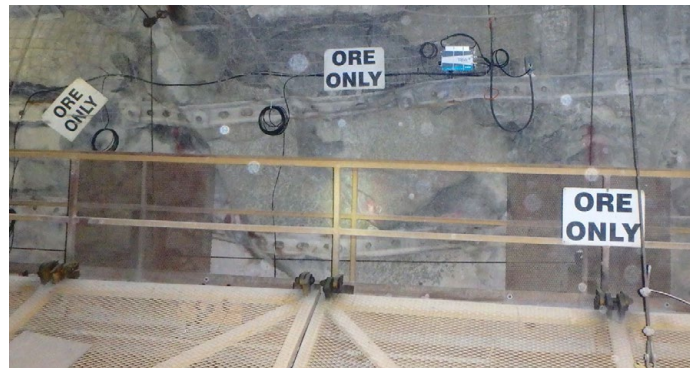
Example of underground rail dump installation.

After a successful test of the TopVu RFID tracking system on one of our underground rail dumps, we moved to implementation of the system on the surface muck streams.

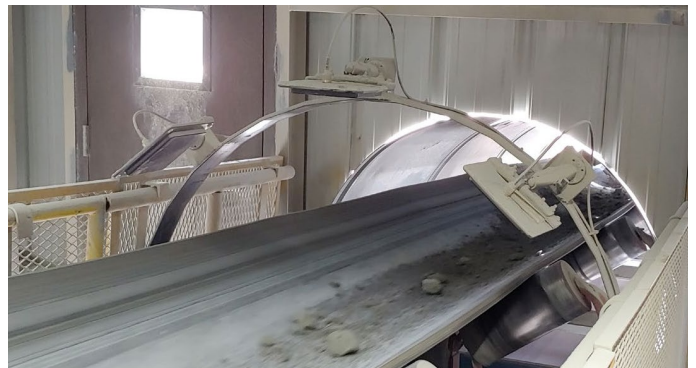
Silo ore belt TopVu installation (skipped ore muck from the shaft).

- 1.) Our silo ore belt where product skipped up the shaft to be milled as ore travels.
- 2.) Our upper West and East side ore belt where gravity-fed product from above surface elevation is brought after being hauled out to surface via train.
- 3.) Our waste belt where product that has been deemed uneconomic to mill travels.

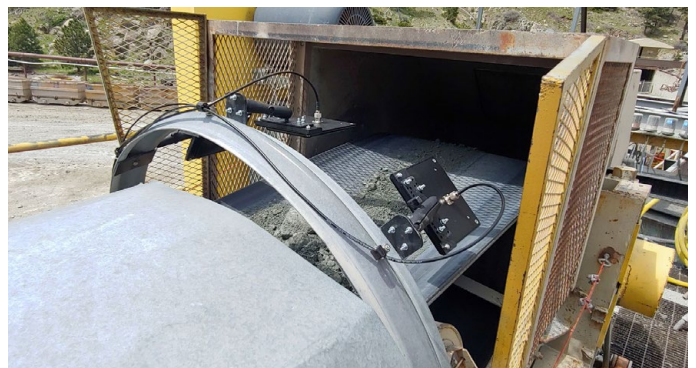
Upper West and East side ore belt installation (muck from above surface elevation hauled by train).
